Interannual coastal processes in Estonia, Peraküla beach monitored by laser scanning technology

M.Eelsalu, **K.Pindsoo**, T.Soomere and K.Julge
Department of Cybernetics at Tallinn University of
Technology
Katri.Pindsoo@ioc.ee

2nd Baltic Earth Conference, Helsingør, 11–15 June 2018

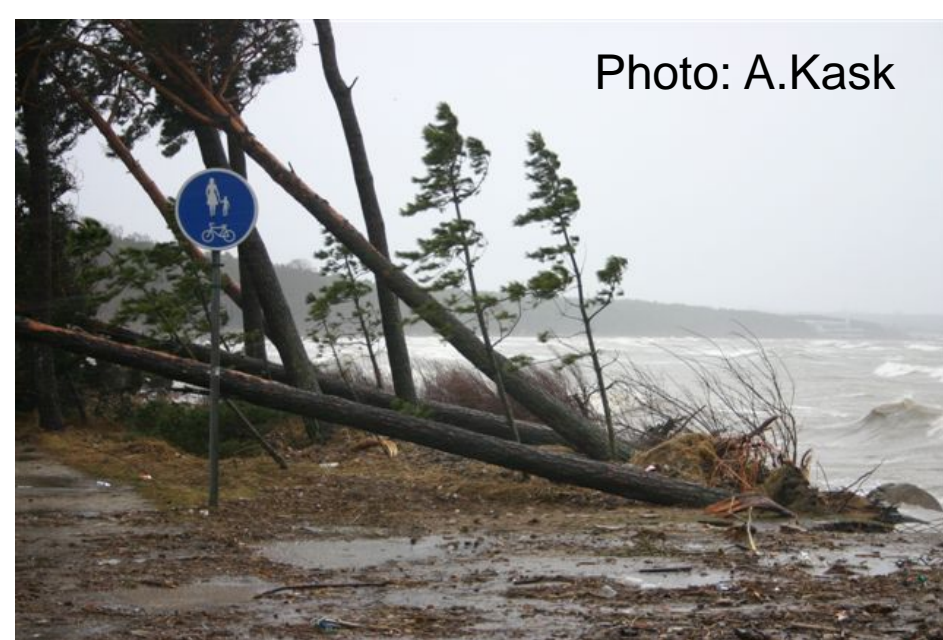
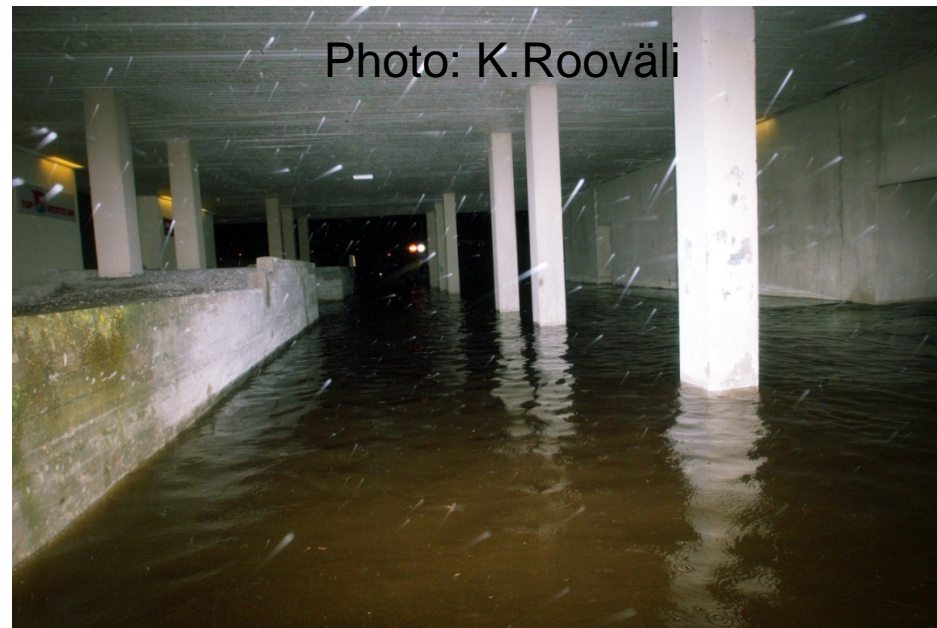
Severe erosion in the sedimentary beaches of the Baltic Sea:

- High waves approaching from extraordinary directions are sometimes combined with (relatively) high water level

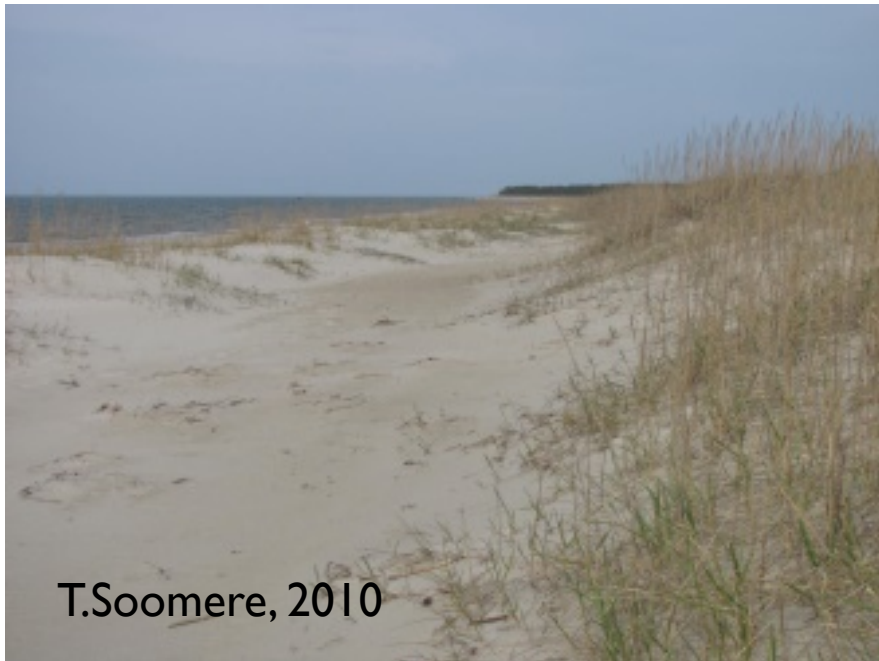
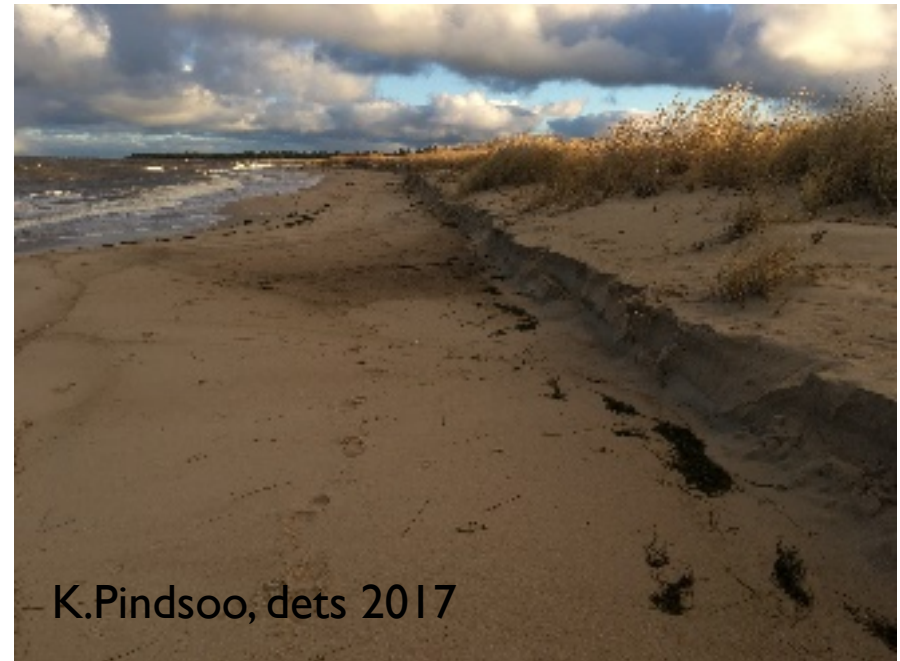
Storm in the study area (Nov 2017):

- Strong wave storm on the background of average water level (+0.2 m)
- Remarkable erosion: sharp scarp was developed
- Local media reported of the erosion scarp of 2 m

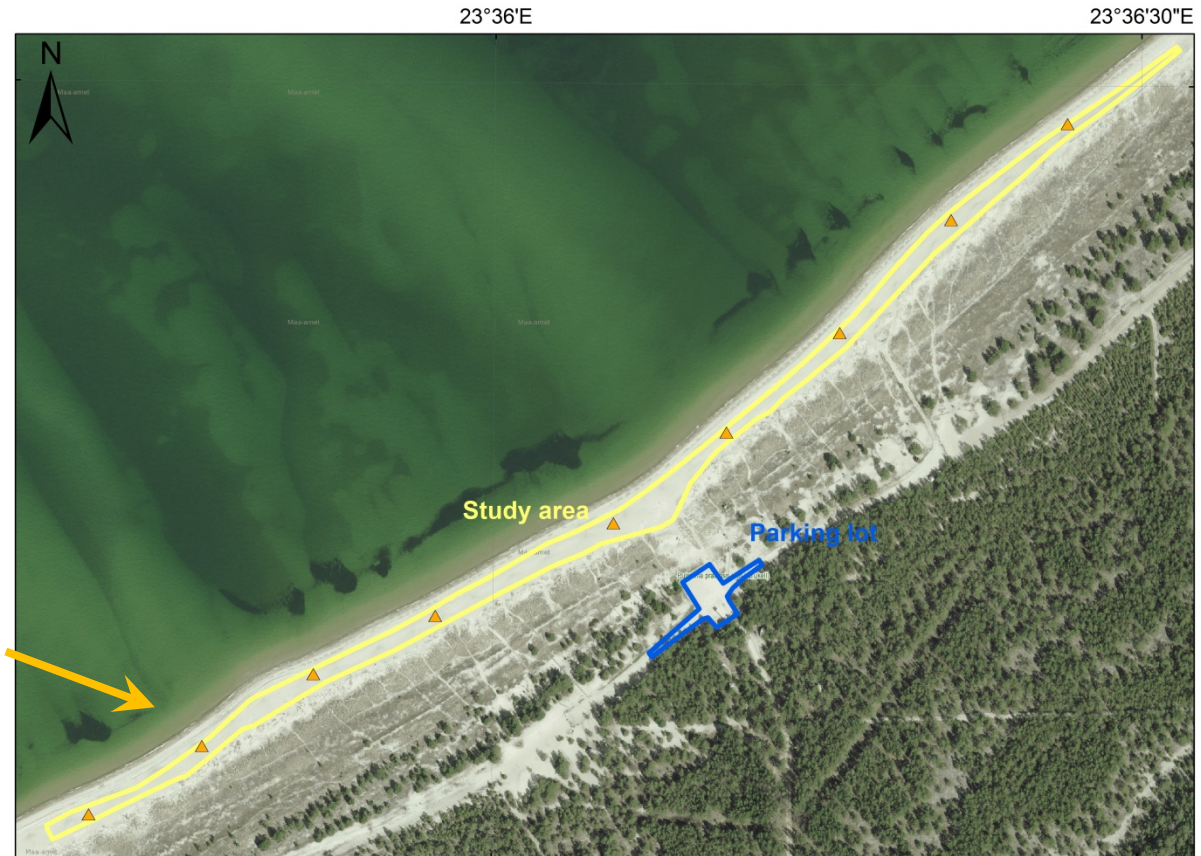
Terrestrial laser scanning (TLS)

- TLS device: Leica ScanStation C10
- Heights of the reference points: determined by levelling benchmark nearby

- **TLS survey:**

- May 2015 and December 2017
- Spatial resolution
~2*2 cm
- 9 scanning stations

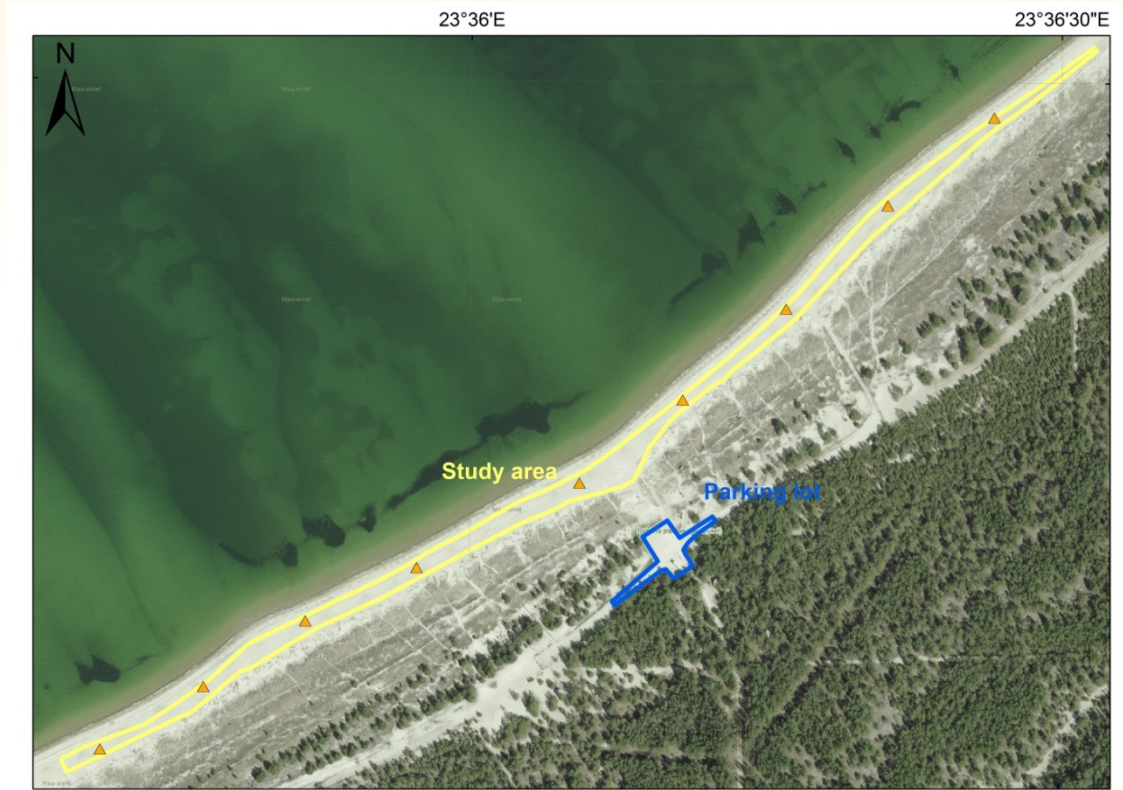
Combining ALS and TLS

- Differences in spatial resolution
- Elimination of systematic errors: applying elevation differences from a steady horizontal surface (Julge et al., 2014)
- Data sets linked by parking lot

- **Result:** 3D Digital Elevation Models of the study area
- **Possible to identify:** changes to the volume of each part of the beach and in the spatial structure

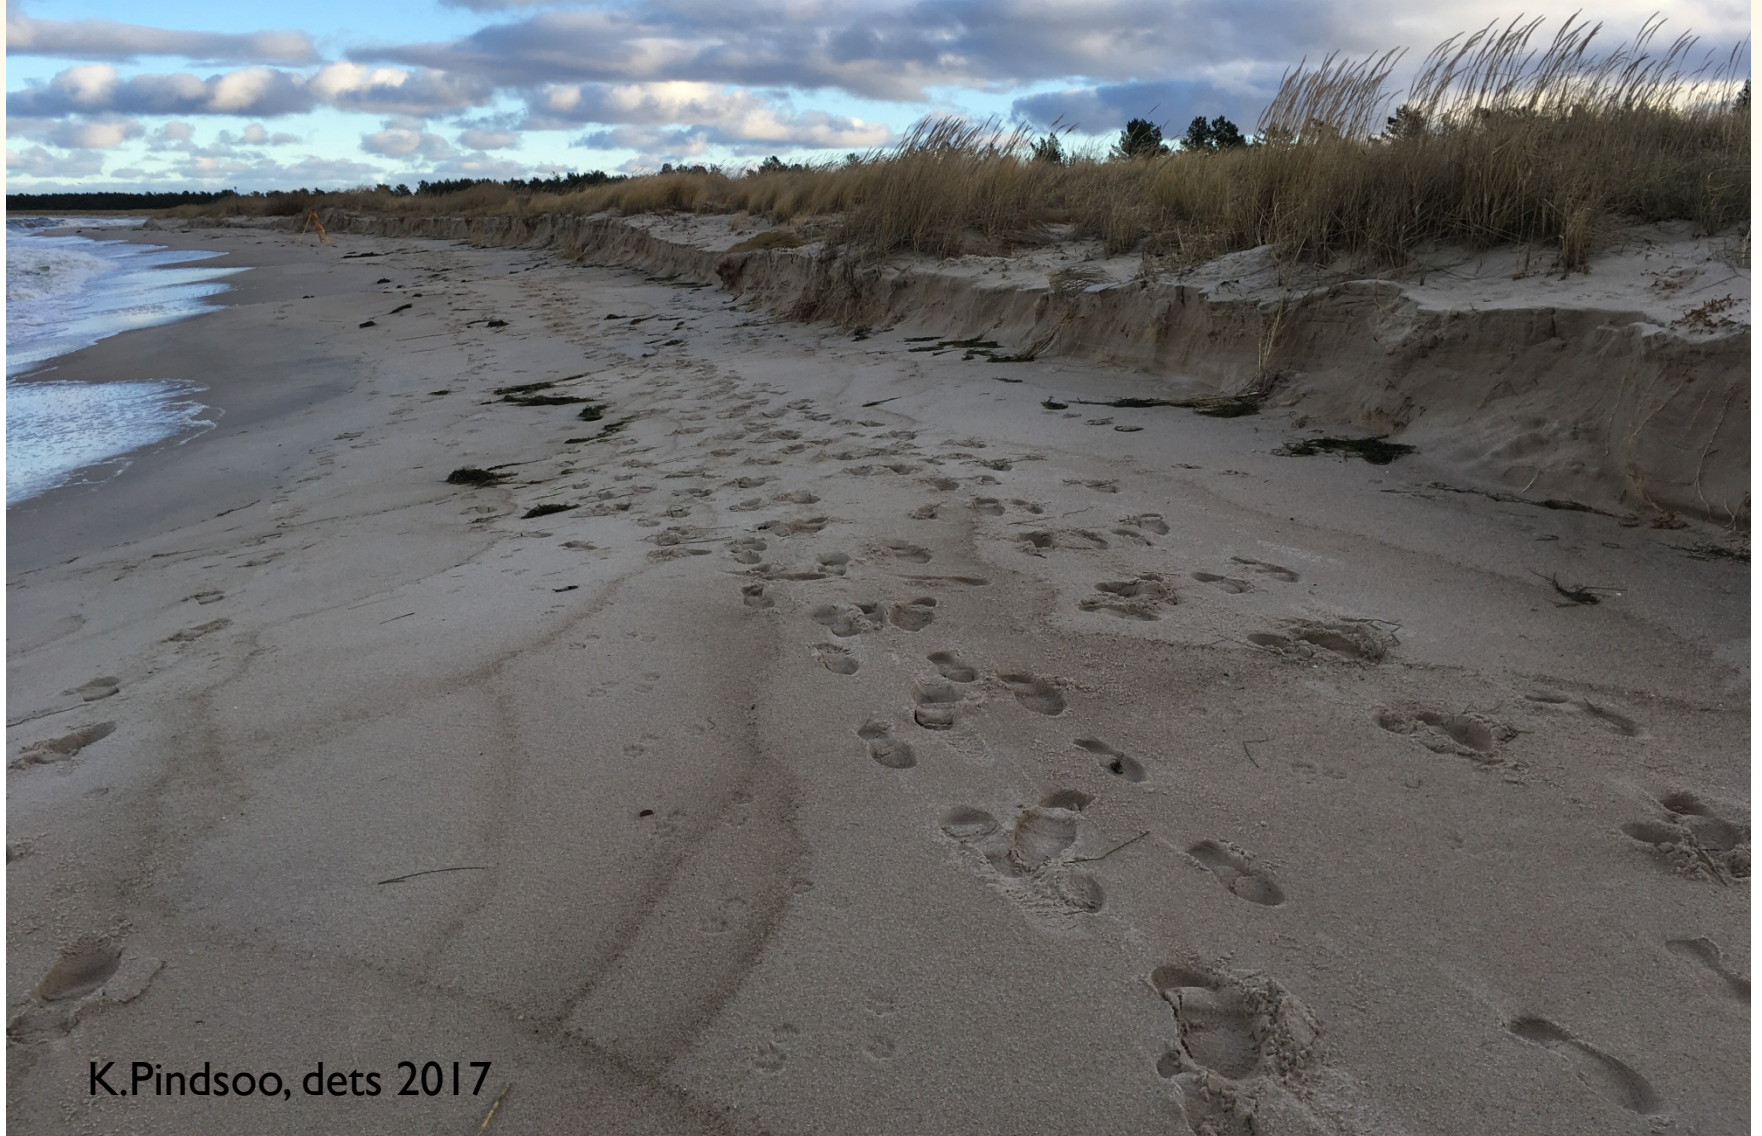
After storm in November 2017
